AFWAL-TR-85-3125

AIRCRAFT TRANSPARENCY TEST METHODOLOGY

Final Technical Report for Period June 1984 - September 1985

FLIGHT DYNAMICS LABORATORY
AIR FORCE WRIGHT AERONAUTICAL LABORATORIES
AIR FORCE SYSTEMS COMMAND
WRIGHT-PATTERSON AIR FORCE BASE, OHIO 45433

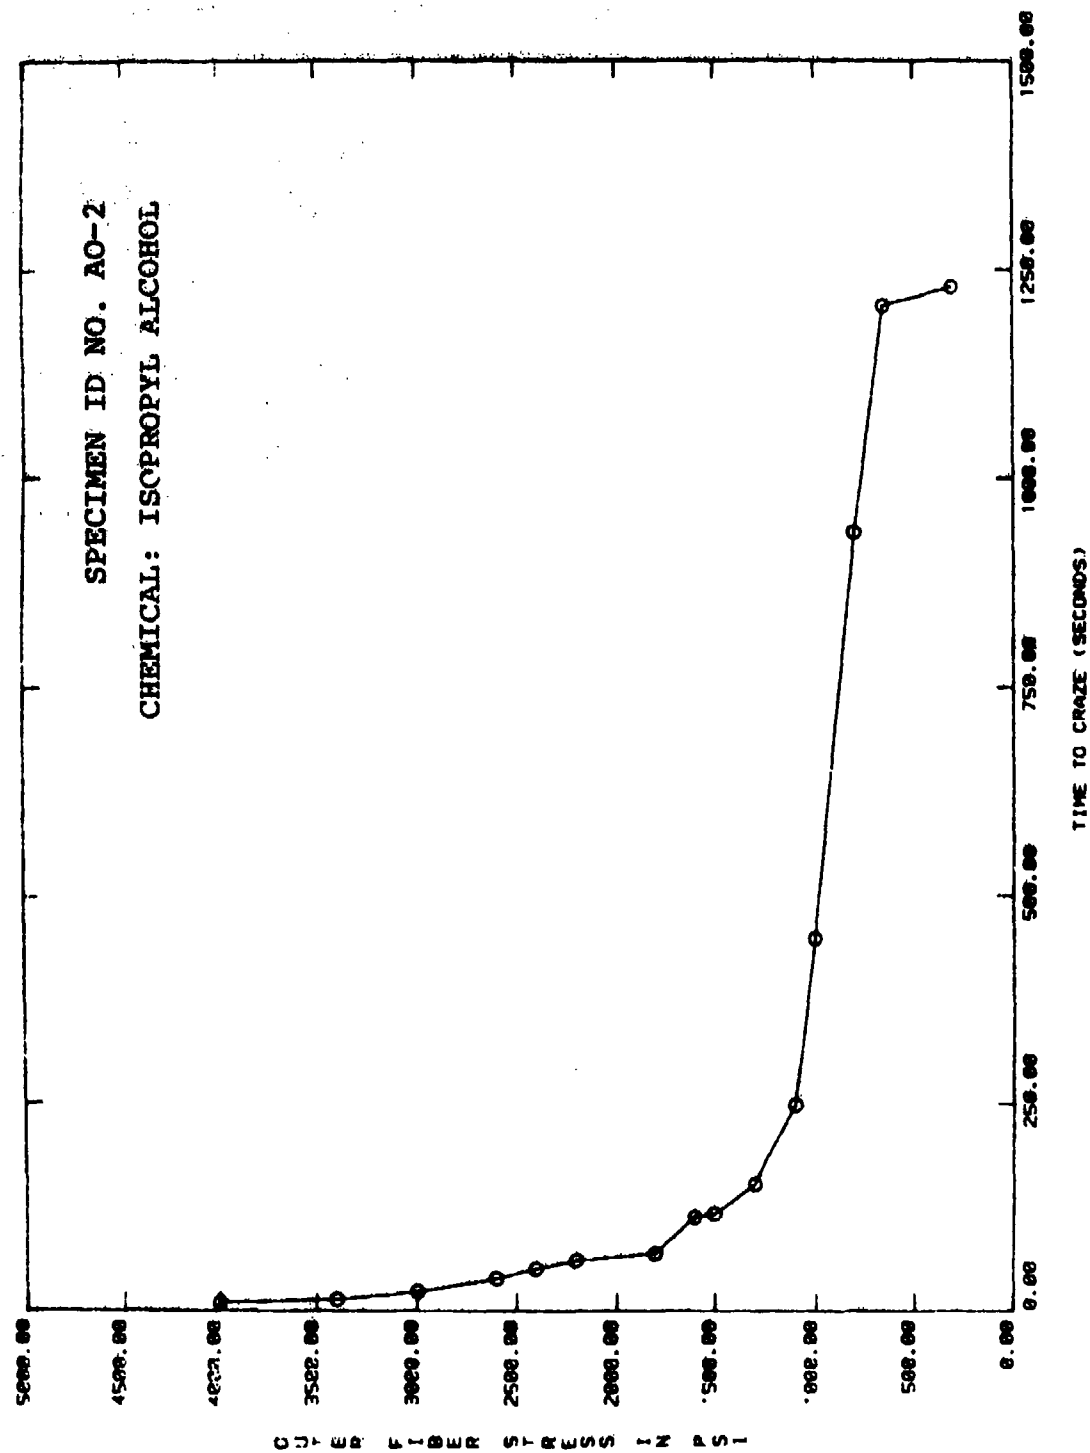
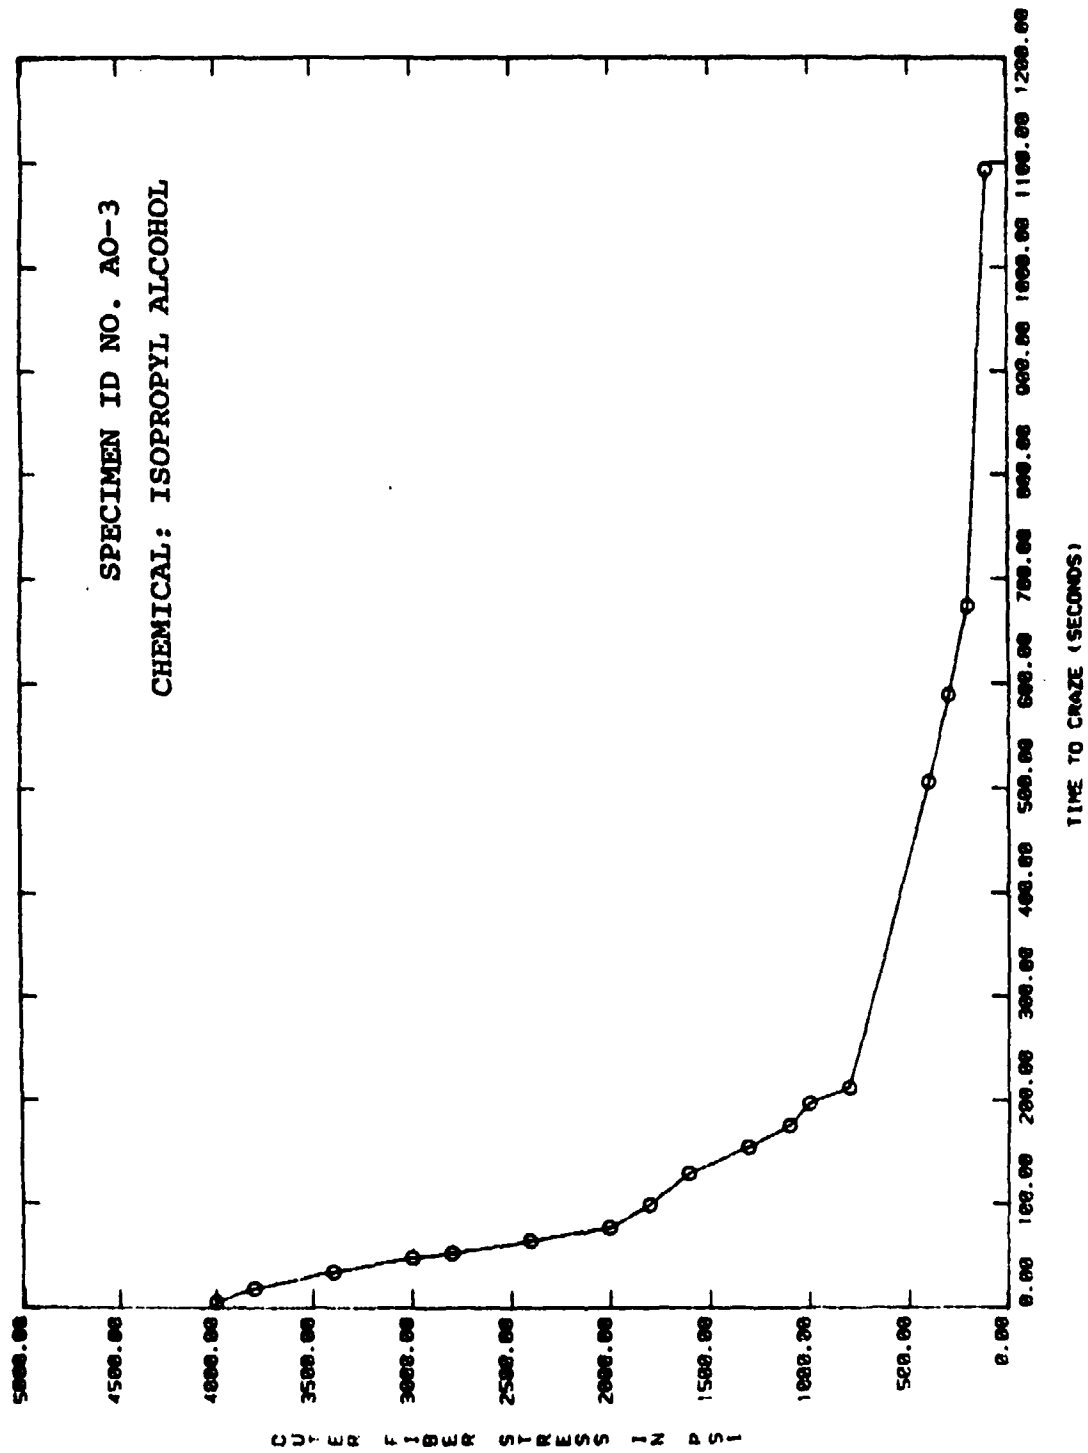
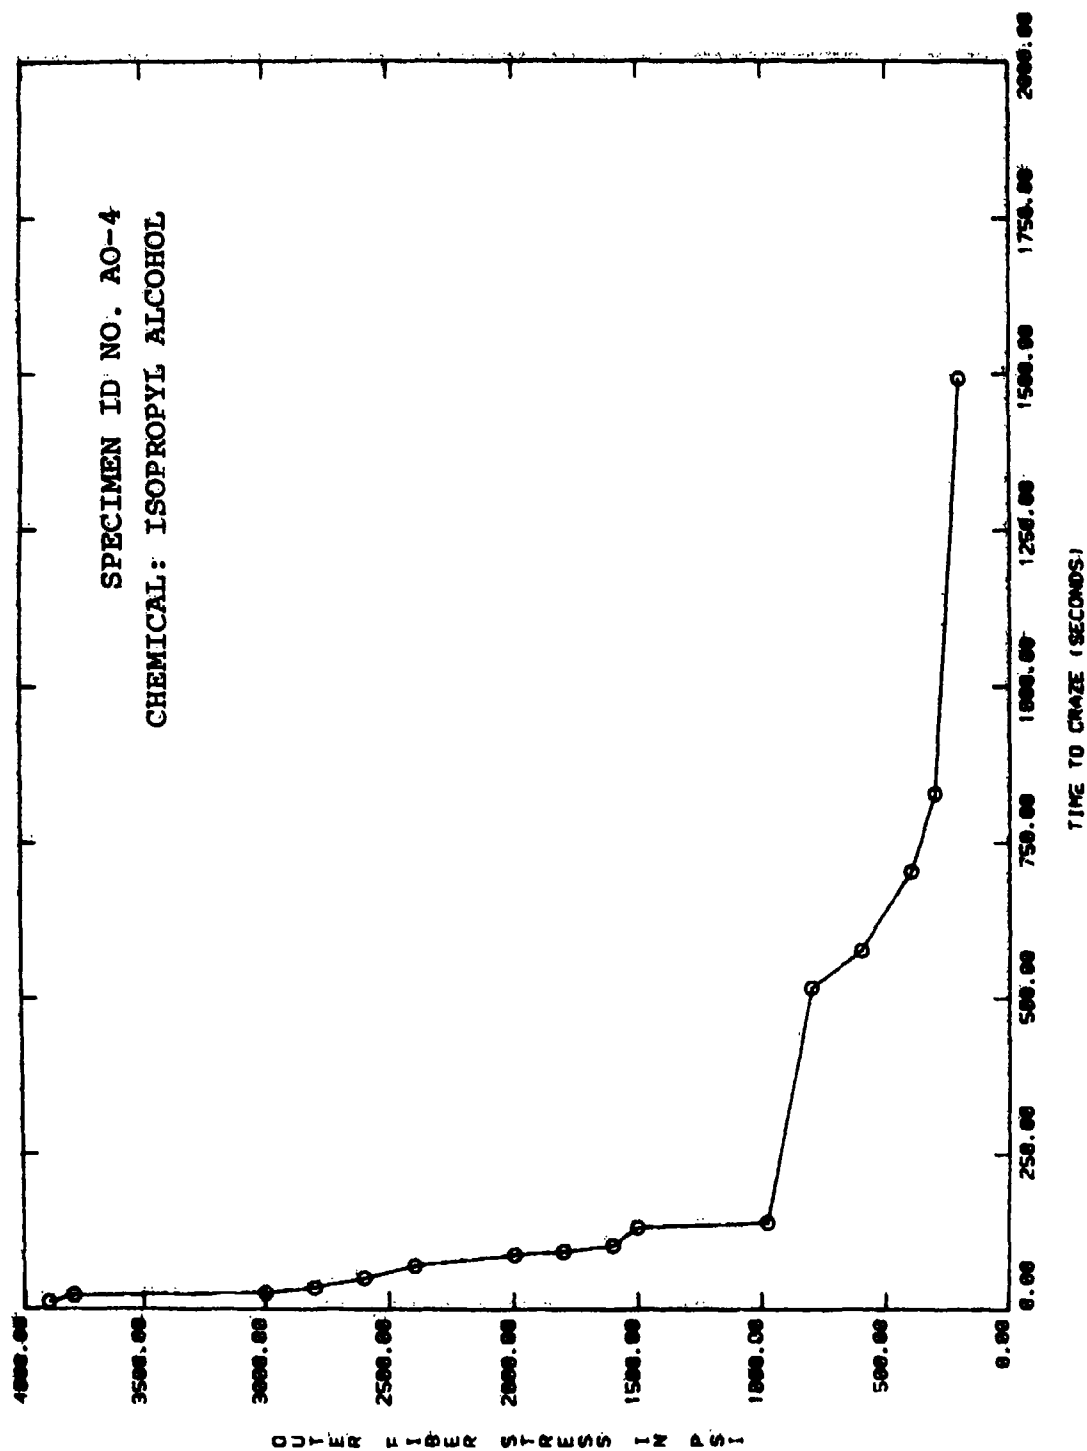
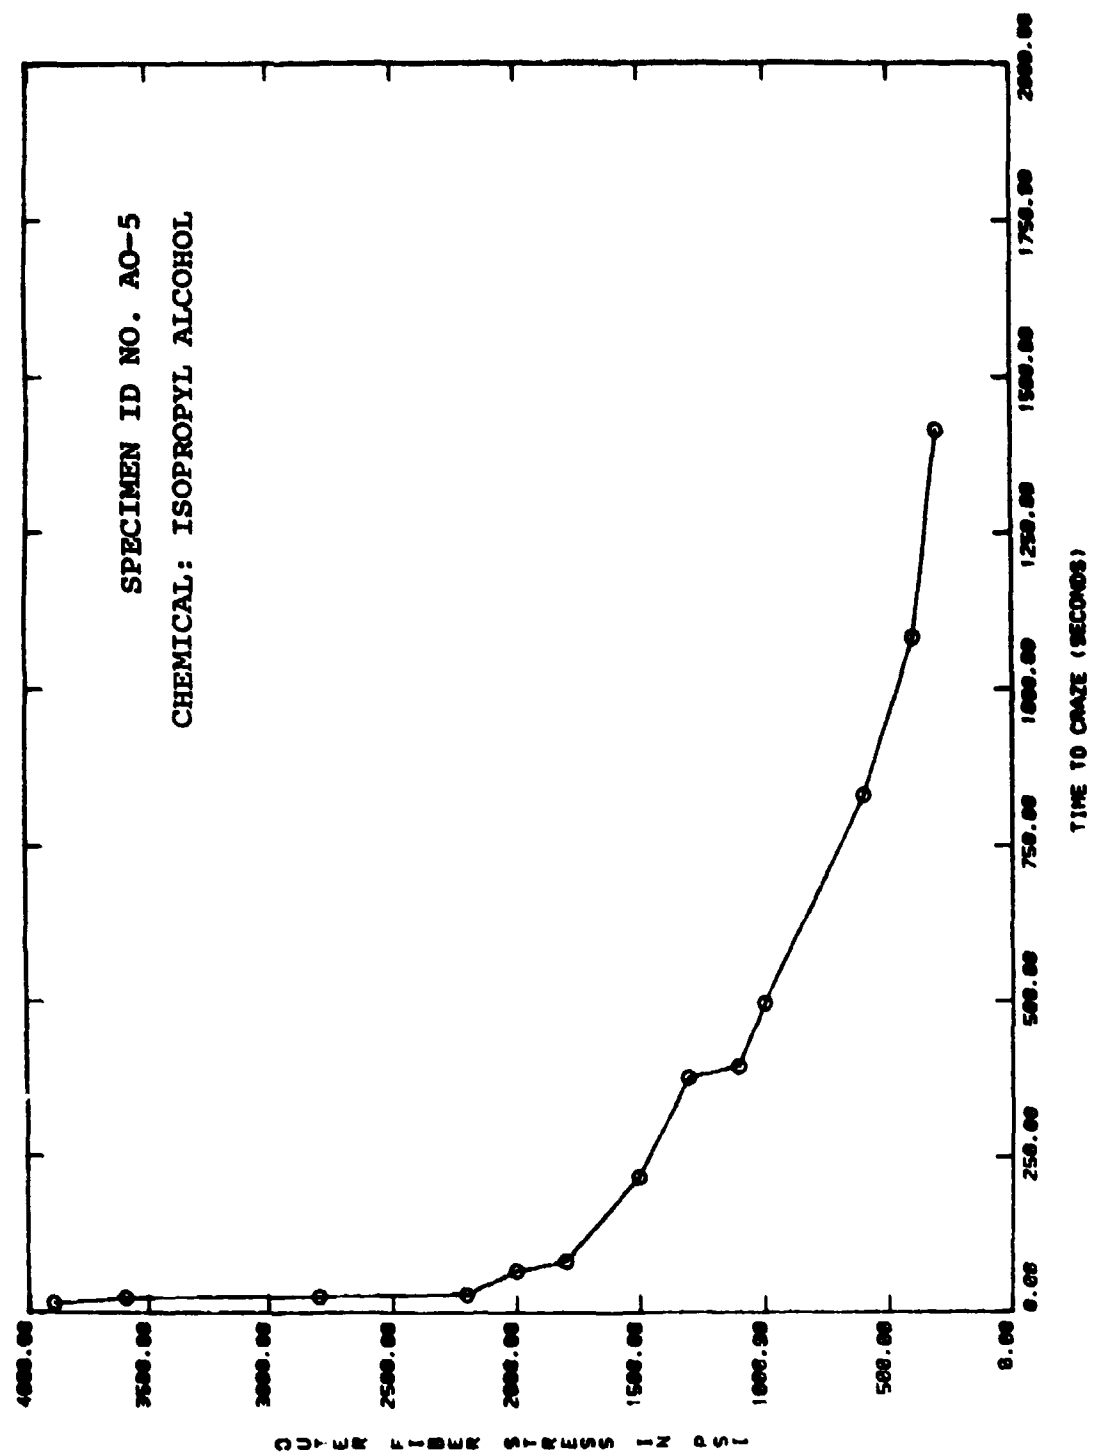
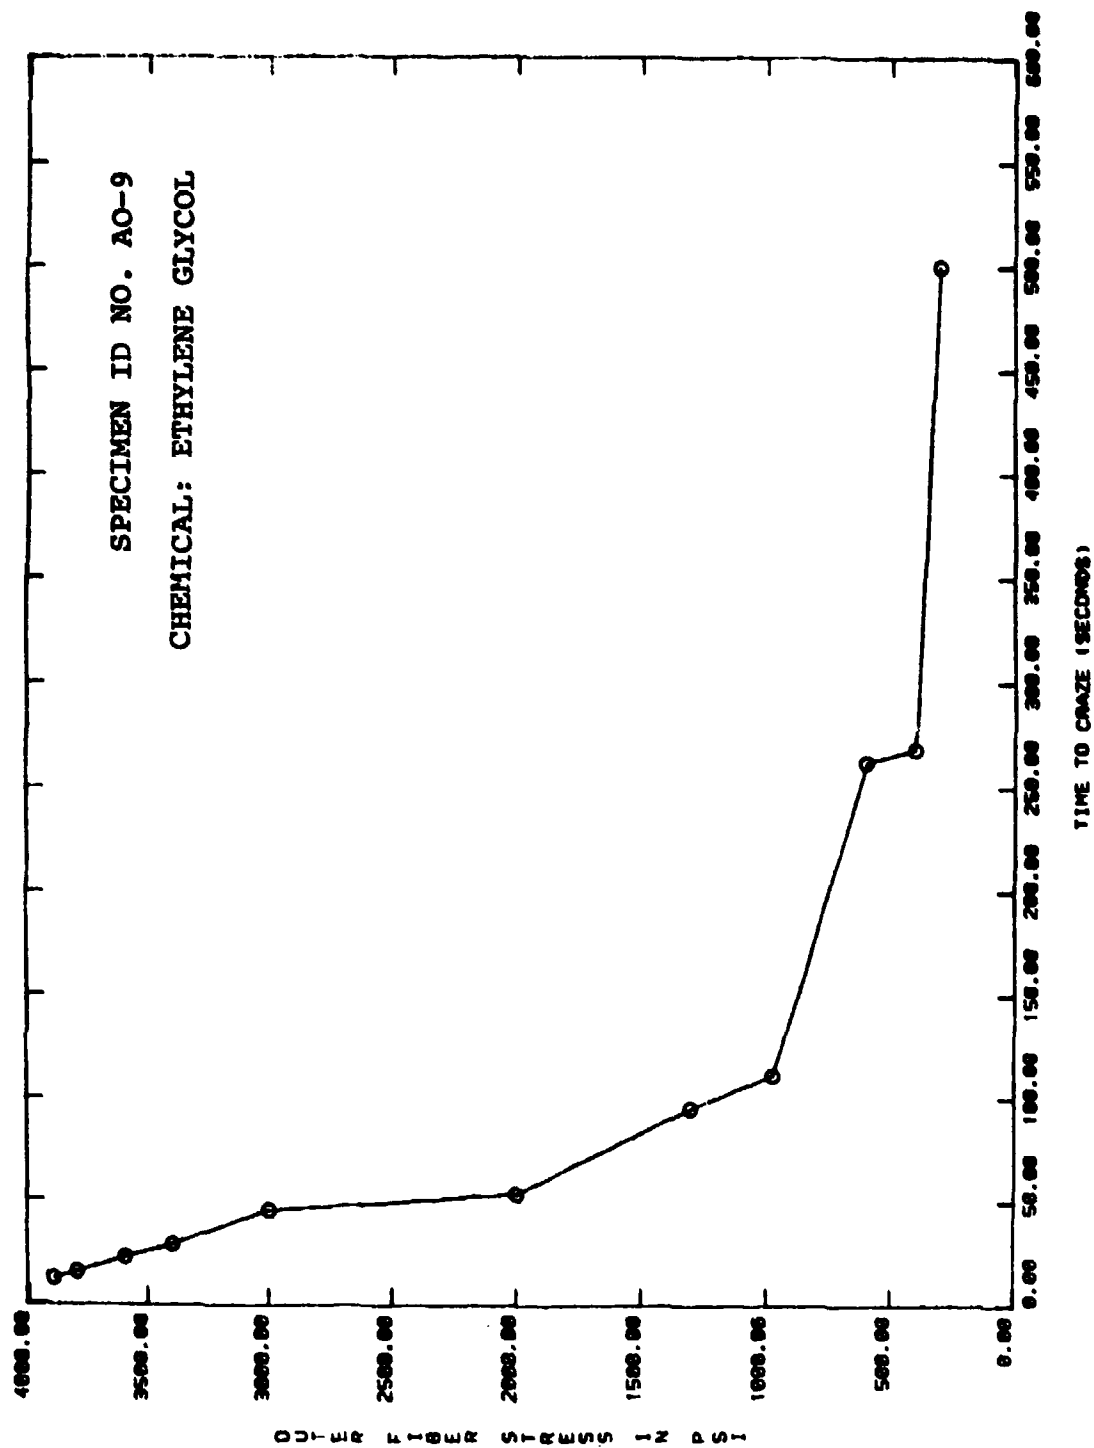
Figure A-11. Plot of Outer Fiber Stress vs. Time to Craze for the F-15 Monolithic Stretched Acrylic Windshield Specimens.

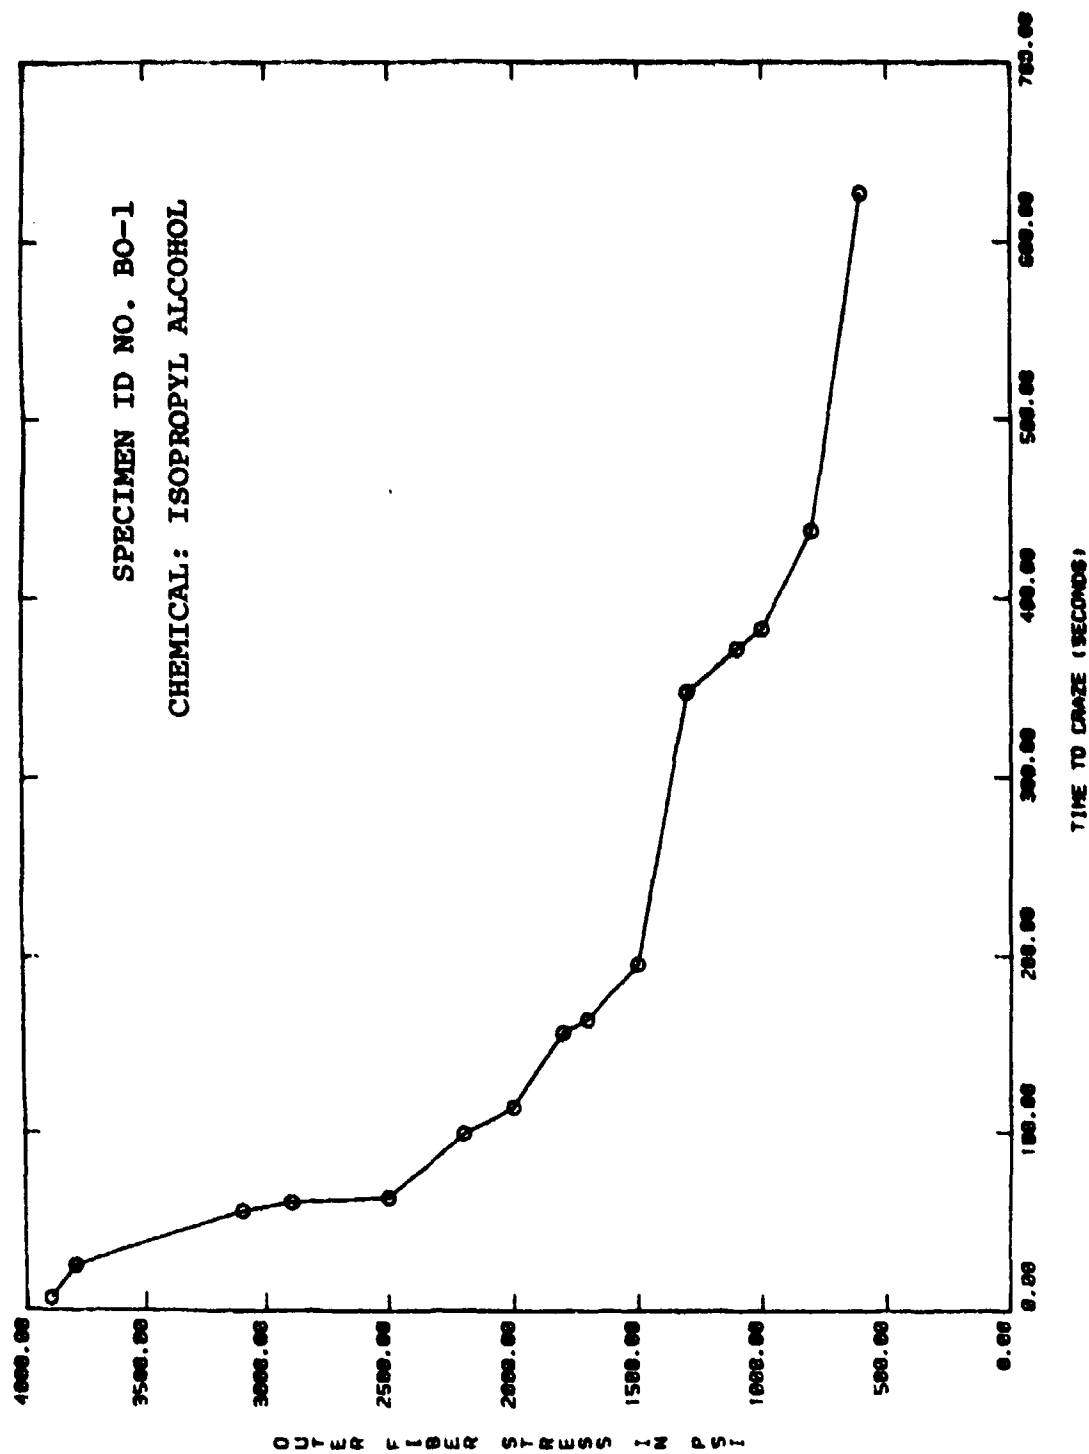
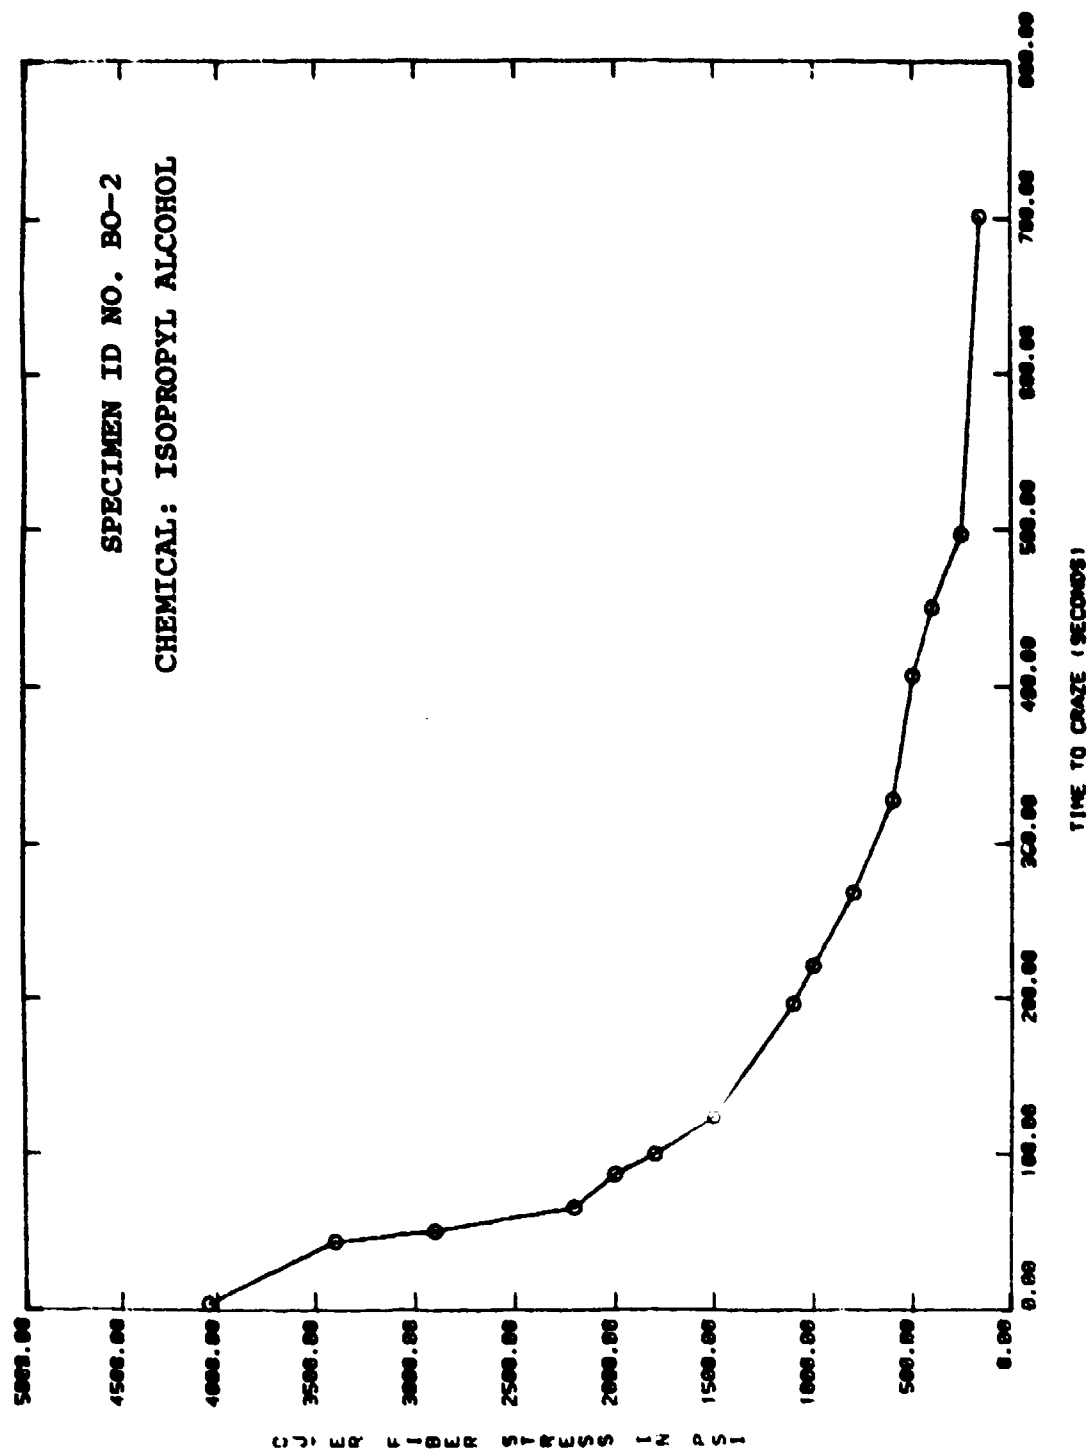
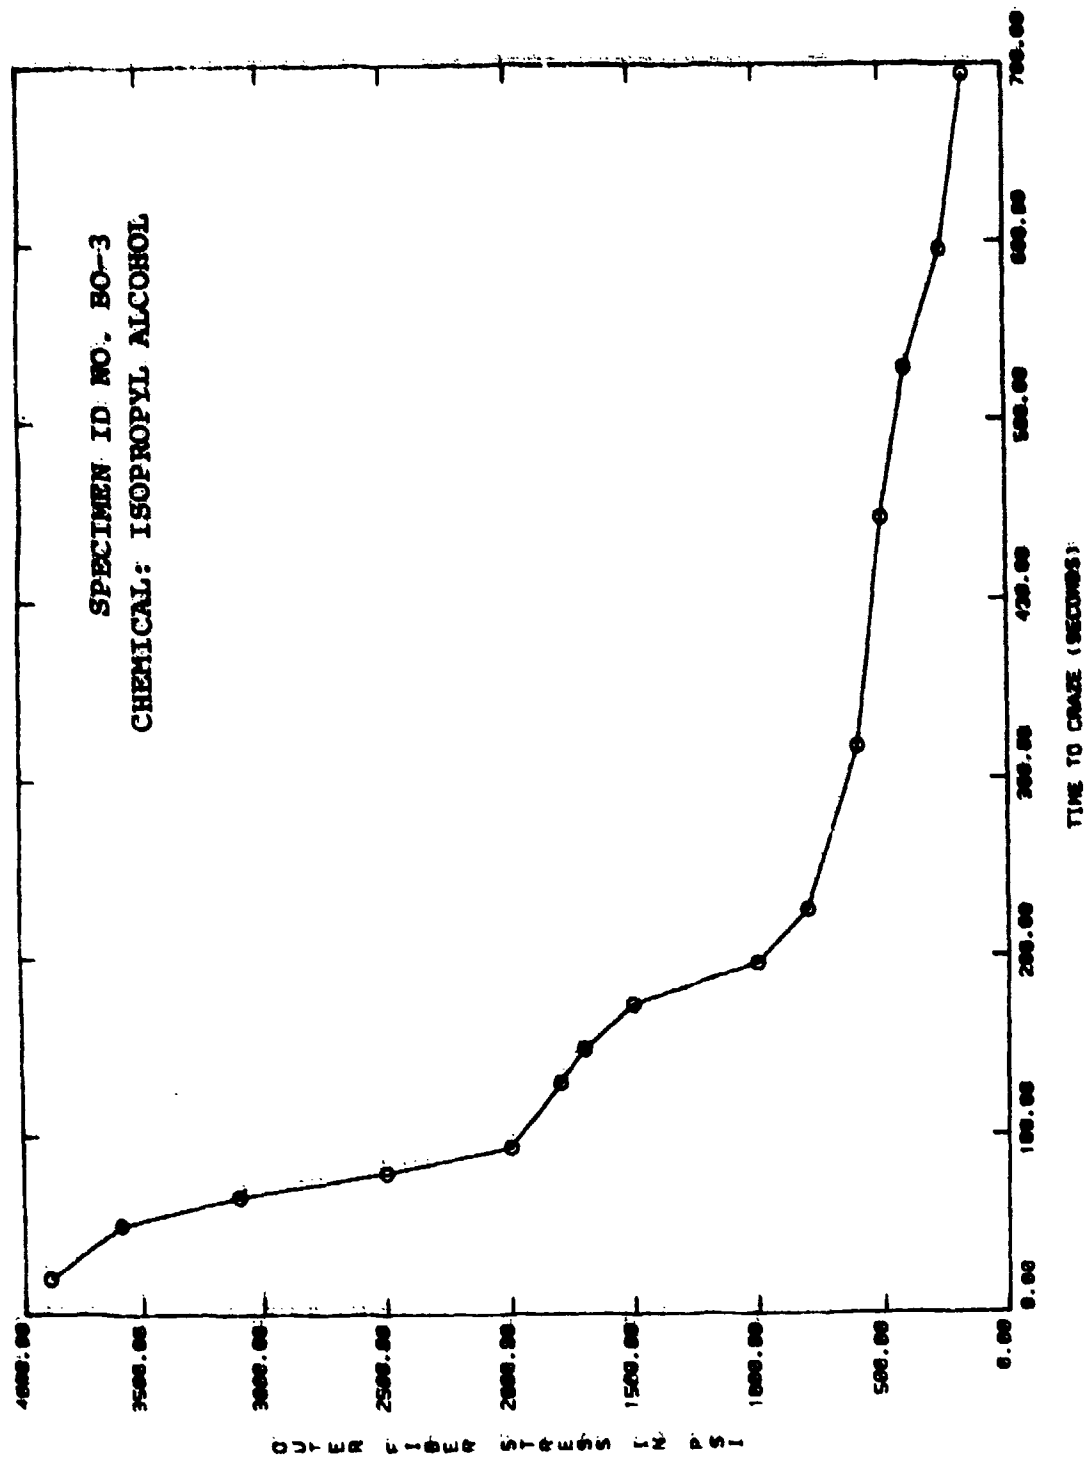
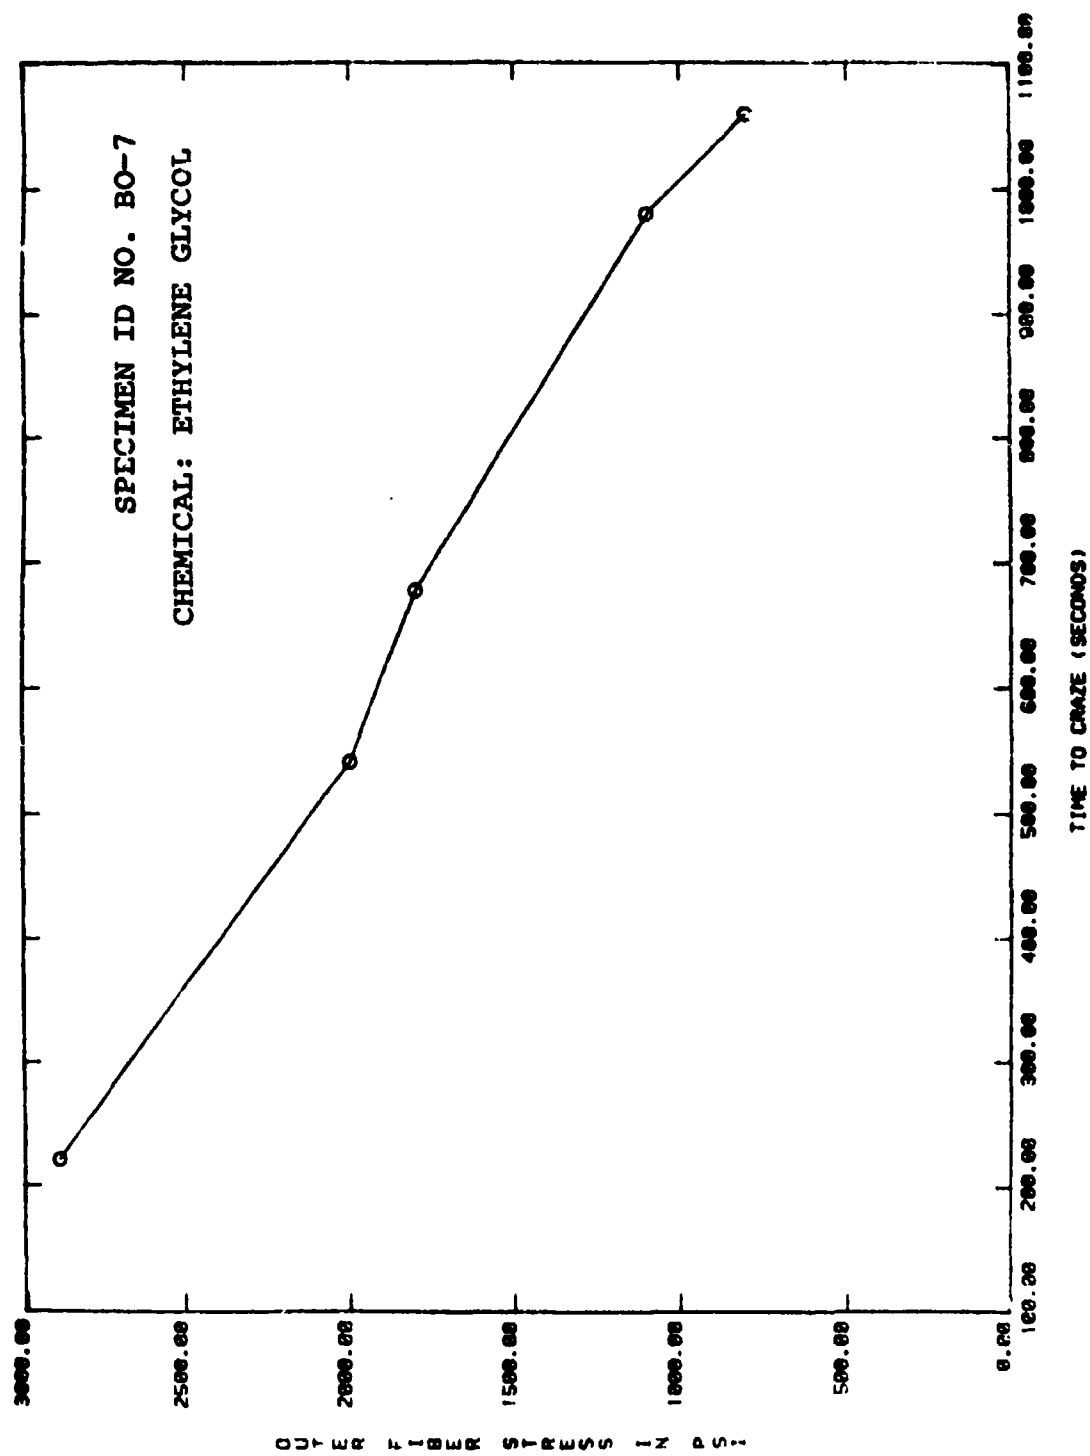
Figure A-12. Plot of Outer Fiber Stress vs. Time to Craze for the P-15 Monolithic Stretched Acrylic Canopy Specimens.
